# FALCON & COMMODORE TROUBLESHOOTING

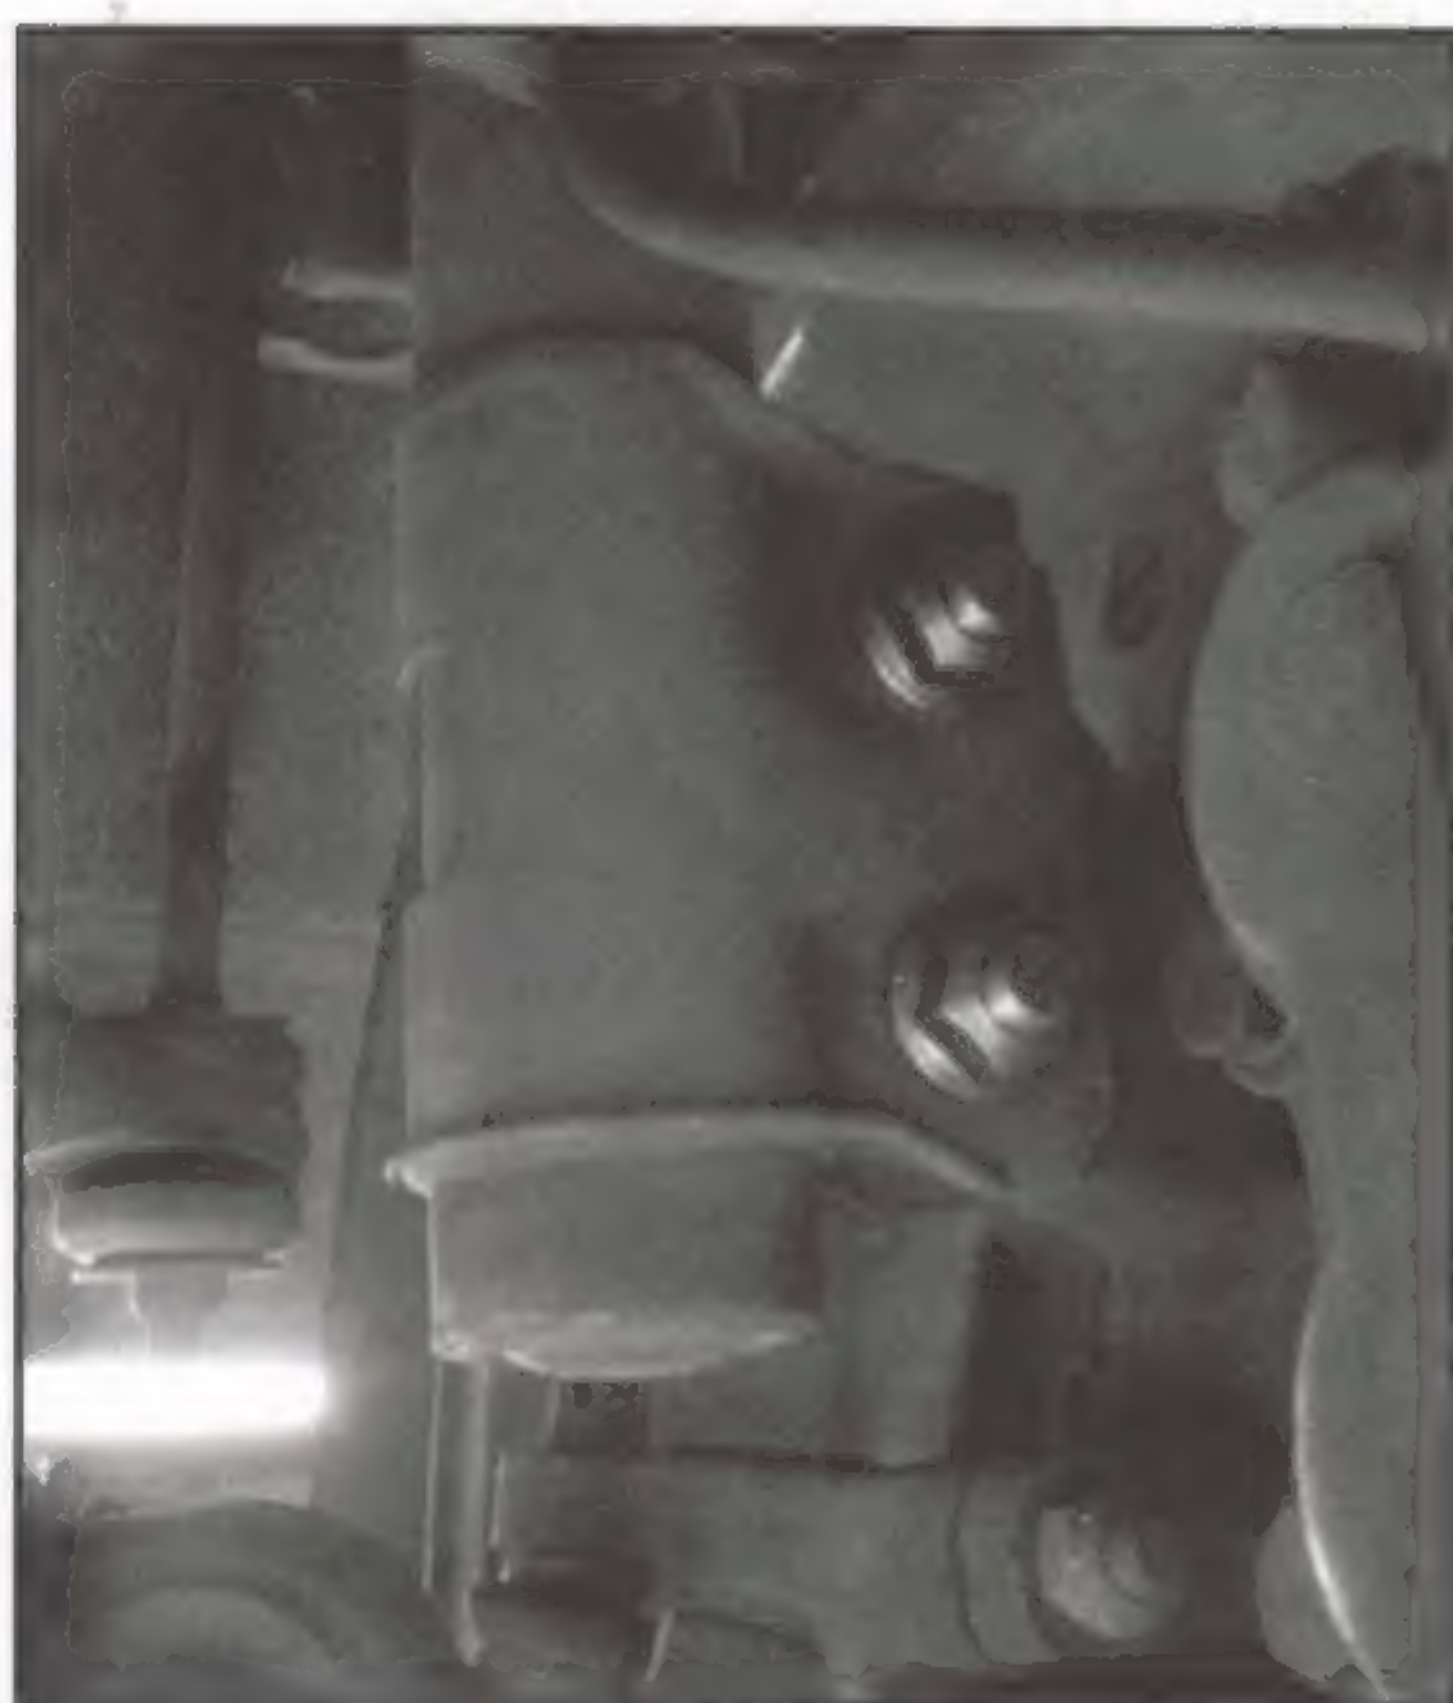
On VR - VT Commodores, the most common bolt in the suspension to be undone is the strut's clevis bolt that is a TTY. These bolts must be replaced whenever they are removed or loosened.

Above: The Clevis bolts or TTY bolts on a VR Commodore

**Note:** to adjust the camber on these Commodore models, both clevis bolts have to be undone!

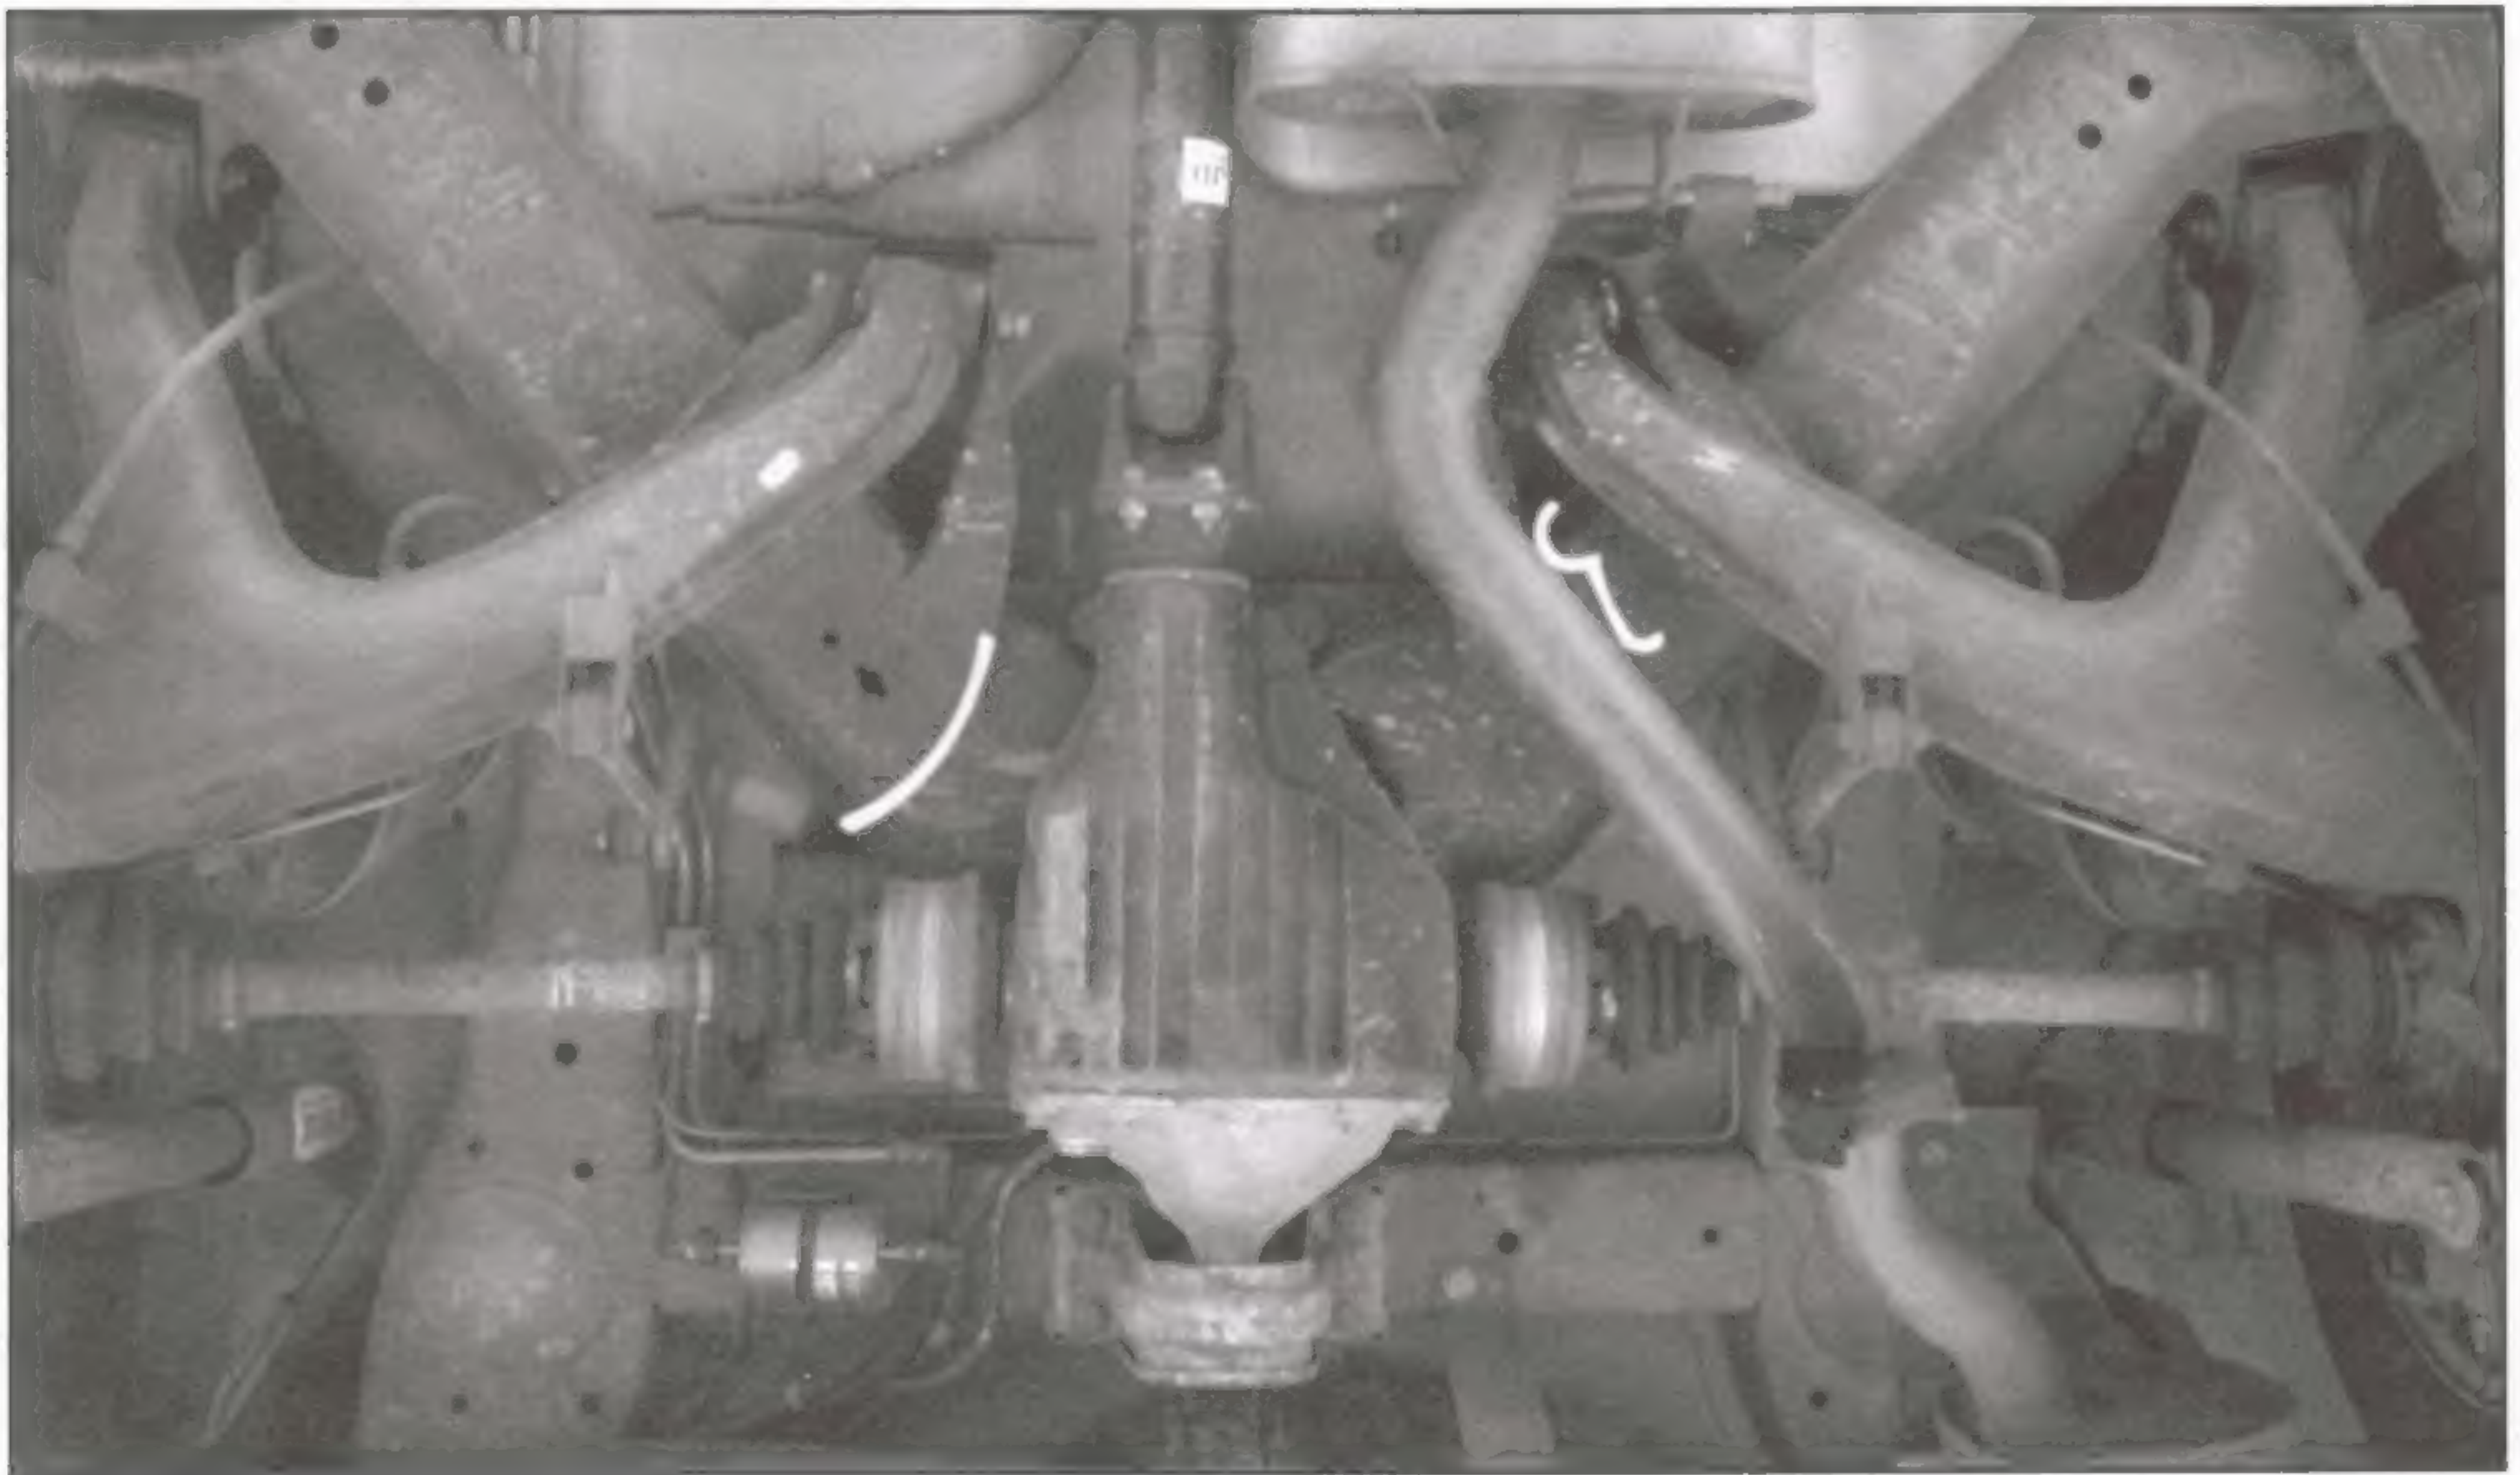
There have been isolated instances of the IRS cross member cracking and eventually breaking on VR & VS models. The failure occurs on the structural cross member between the trailing arm's inner pivot mounting and the differential carrier mounting bolts.

- A click or creaking noise as the vehicle accelerates or brakes
- Rear steer symptom similar to a broken rear leaf
- Severe thumping or banging
- Rear end steps out under acceleration
- Severely out of specification rear toe and camber
- Loss of drive

If the cross member breaks completely, the result can be that the axle is pulled out of the differential carrier.

**This image shows the potential fatigue points of the IRS cross member in a VT Commodore.**
